JANE PIT, WORKINGTON, CUMBRIA

Desk-Based Assessment and Landscape Survey Report

Oxford Archaeology North

October 2016

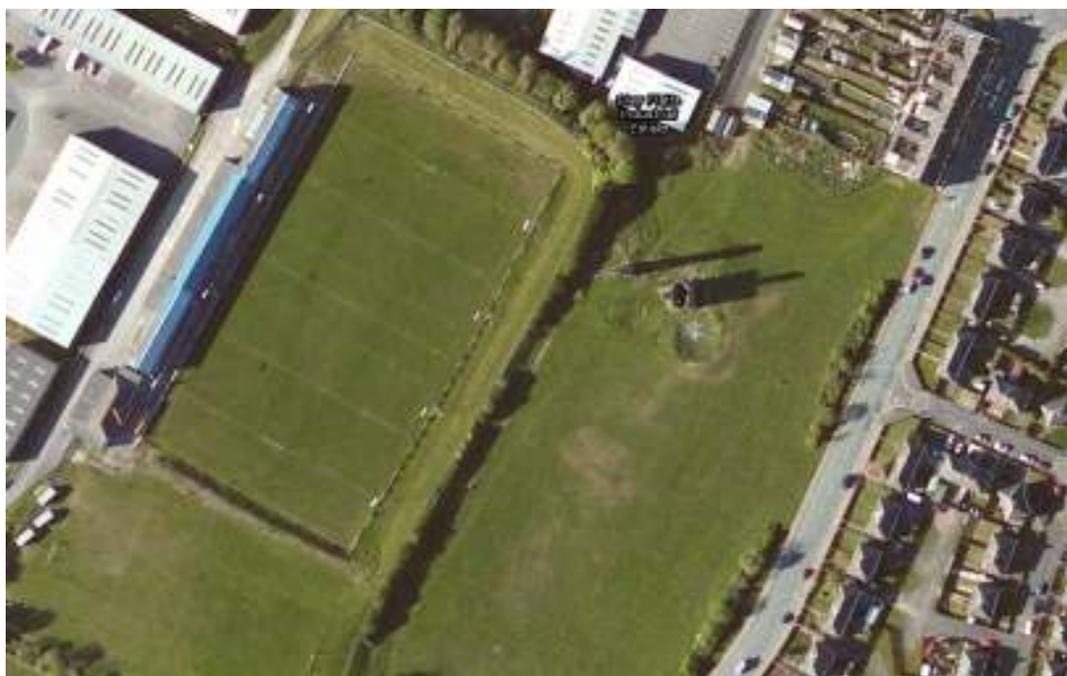
1.2.1 **Location:** the site of Jane Pit is at NGR 299522 527778 (Fig 1), and is to the south-west of Workington town centre, south of Annie Pit Lane and west of Mossbay Road. It is adjacent to allotments and playing fields in an area where three colliery pits (Annie Pit, Buddle Pit and Jane Pit) were worked during the middle of the nineteenth century. The land is flat, and slopes gently towards the shore (Plate 1).

Plate 1: Recent Aerial Photograph of Jane Pit

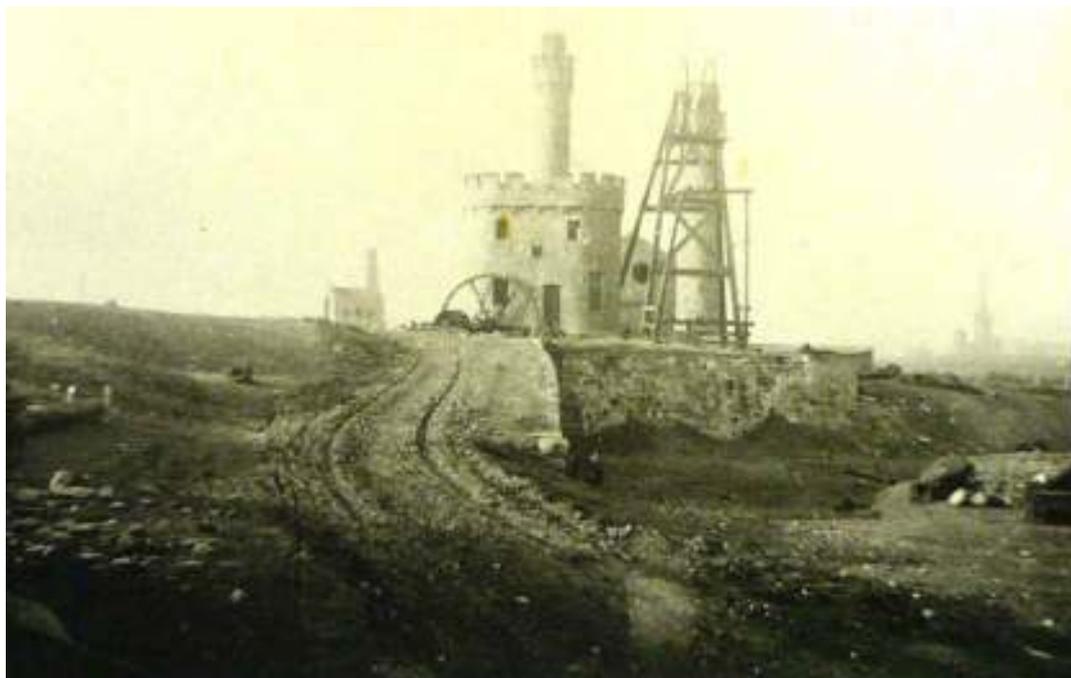
- 3.4.18 The Jane Pit buildings were of stone ‘and the head-gear, when it existed, was made of wood’ (John J Martin, August 10th 1968, *Times and Star* (DX/655/34)) (Plate 2). This was during a period when brick and iron were beginning to be used and the use of stone and wood seems to have harked back to the traditional architectural techniques, or perhaps was an economy measure.

Plate 2: Extract of photograph of Jane Pit (not dated) (PH/1548/14/7, *photograph of Jane Pit*)

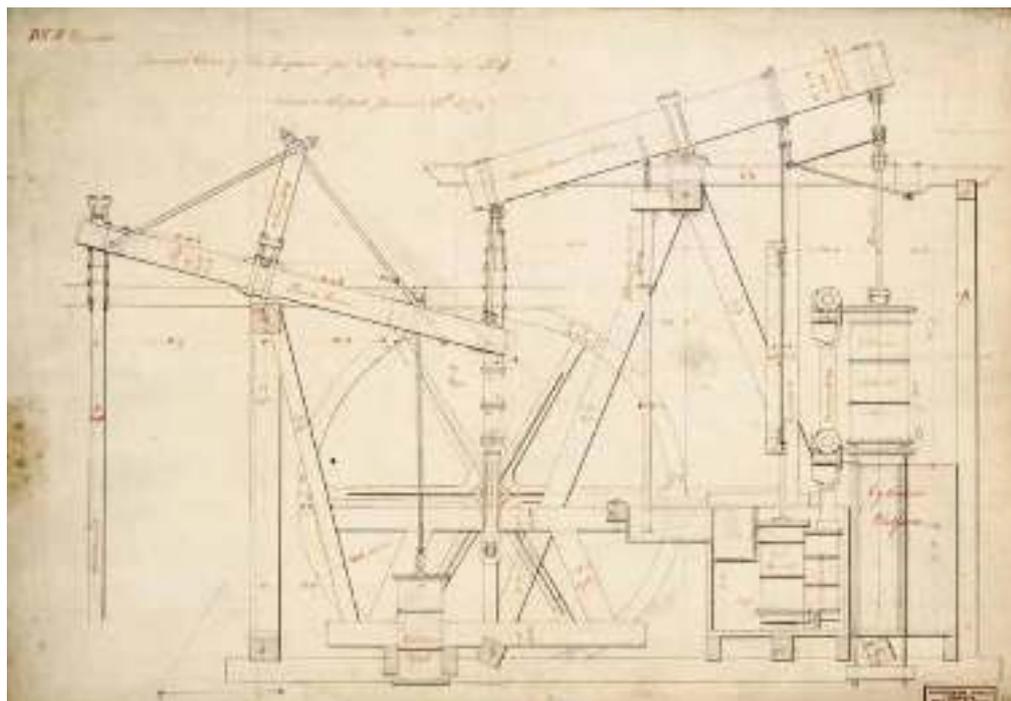
Plate 3: Reverse View of the 40 horse engine for JC Curwen, at Lady Pit, Workington, Cumbria, January 1794 (MS3147/Portfolio/5/247)

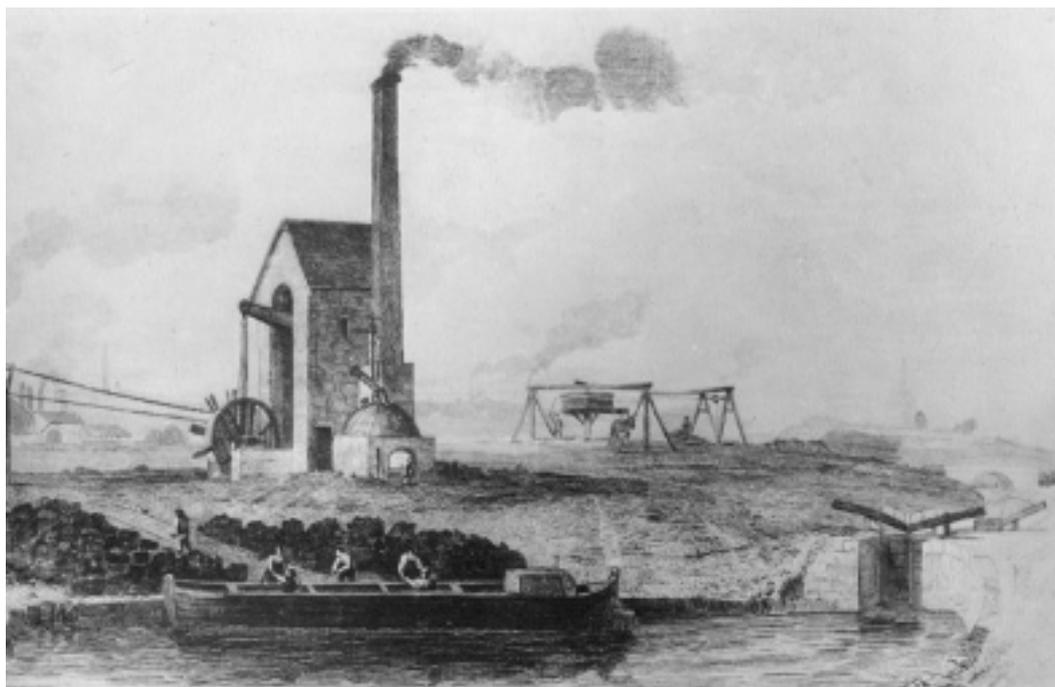
Plate 4: Willenhall in South Staffordshire: a steam-powered winding engine, and a gin pit (www.historywebsite.co.uk)

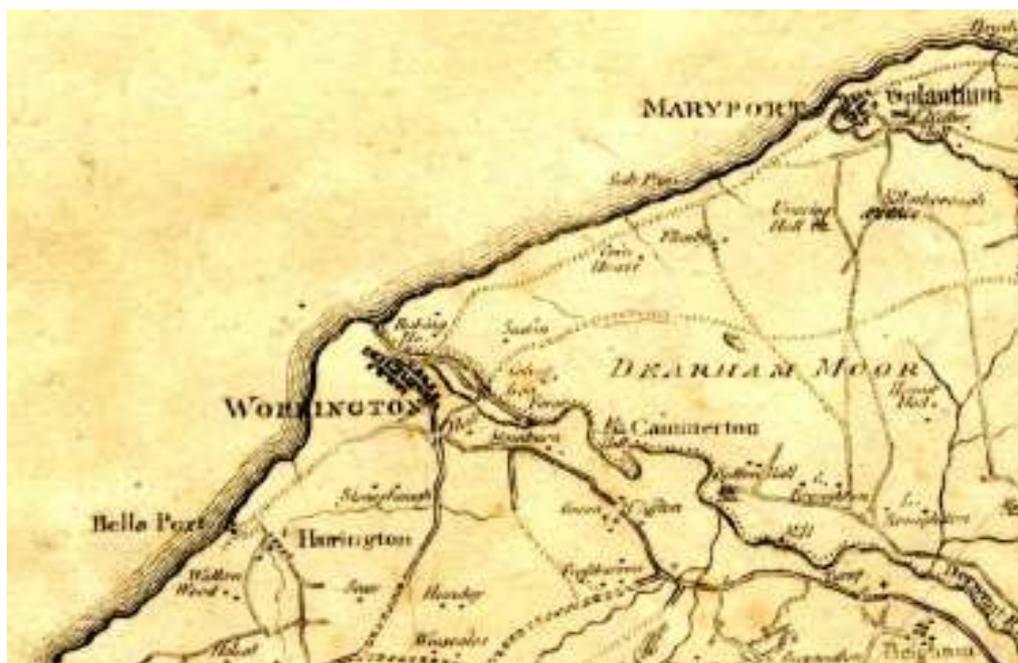
Plate 6: Extract from F Jollie, 1794, *A Map of Cumberland*

- 3.5.2 **F Jollie, 1794, A Map of Cumberland (Plate 6):** F Jollie's map of 1794 Workington is denoted with a detailed depiction of buildings on either side of the road from the junction of the north/south road from Moresby and Whitehaven with that of the east/west road from Brigham going south of the River Derwent (*ibid*). There appeared to have been the main road and a parallel street to the south lined with buildings both leading to the south side of the River Derwent. South of Workington the farm of Stoneyhaugh was marked, and also a road or track leading to Bella Port and Harrington. No industrial workings or mines were marked in this area south of Workington.

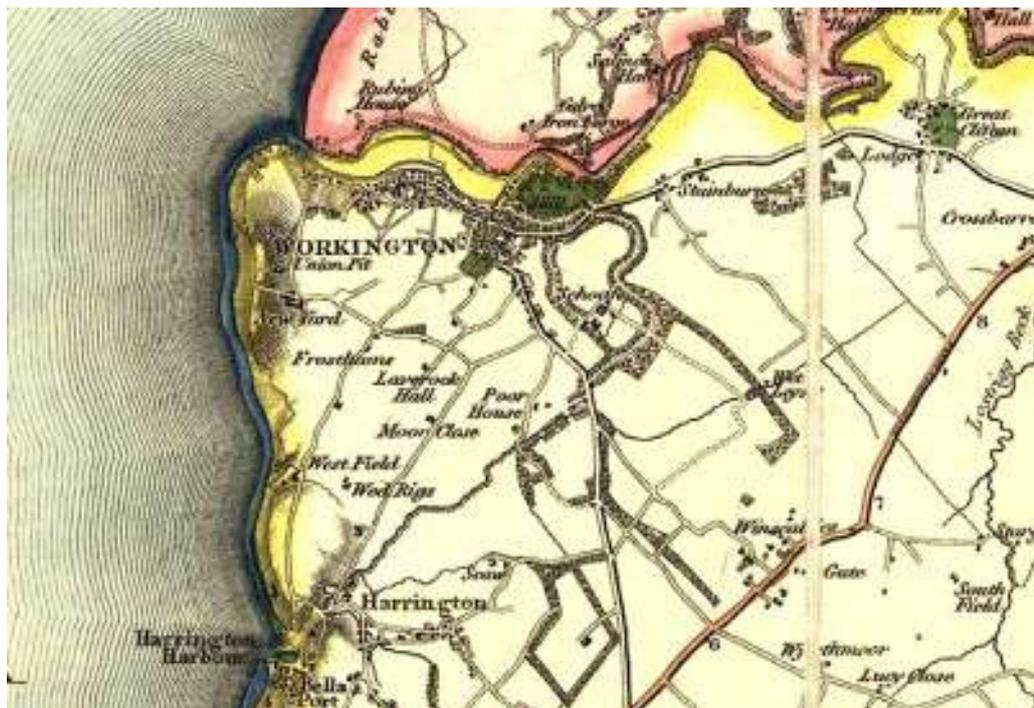
Plate 8: Extract from map by Christopher and John Greenwood, 1824, *Map of the County of Cumberland*

- 3.5.4 ***Christopher and John Greenwood, 1824, Map of the County of Cumberland (Plate 8)***: this map had more detail, thus depicting the growth of Workington as a large town with the hall and park, its residential areas and industrial development along the River Derwent. Calva Iron Forge was to the north of the town. Only one pit was marked and labelled as Union Pit and this was to the south-west of Workington. The Study Area of Jane Pit was west of Frosthams and east of New Yard, which are first mentioned on these maps, but no coal pits were noted in this area.

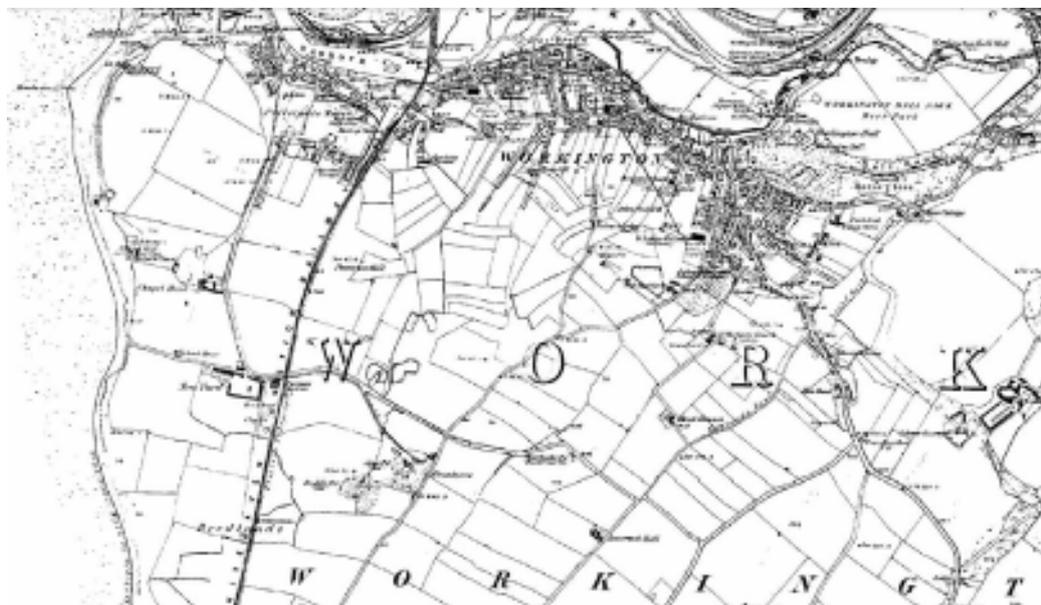
- 3.5.6 The 1st edition OS map depicted Jane Pit and Buddle Pit to the west of Frostoms. Jane Pit had a labelled Shaft, two large roofed buildings, one of which was rectangular with a smaller square extension offset at its east end. The other was L-shaped with two small extensions on its southern and western sides. South of the rectangular building was a small circular roofed structure or bin. All these were north of a trackway leading westwards through the associated slag tips. North-west of the two main buildings was an elongated oval, unroofed, feature thought to have been a reservoir (Davies-Shiel and Marshall 1969, 117).

Plate 10: Extract from 1867 OS map (surveyed 1864), 1:10,560 showing Jane Pit in context of Workington

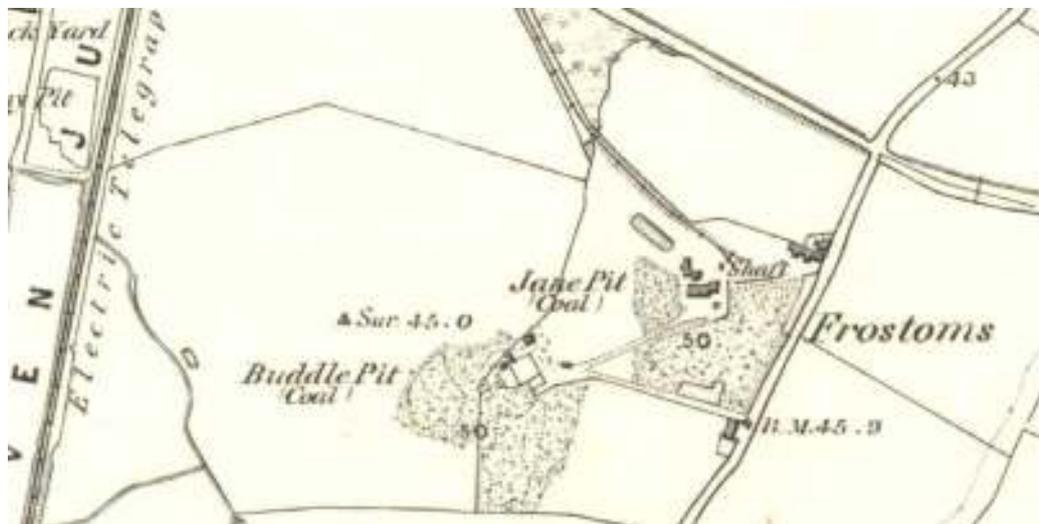
Plate 11: An enlarged extract from the 1867 1:10,560 OS map

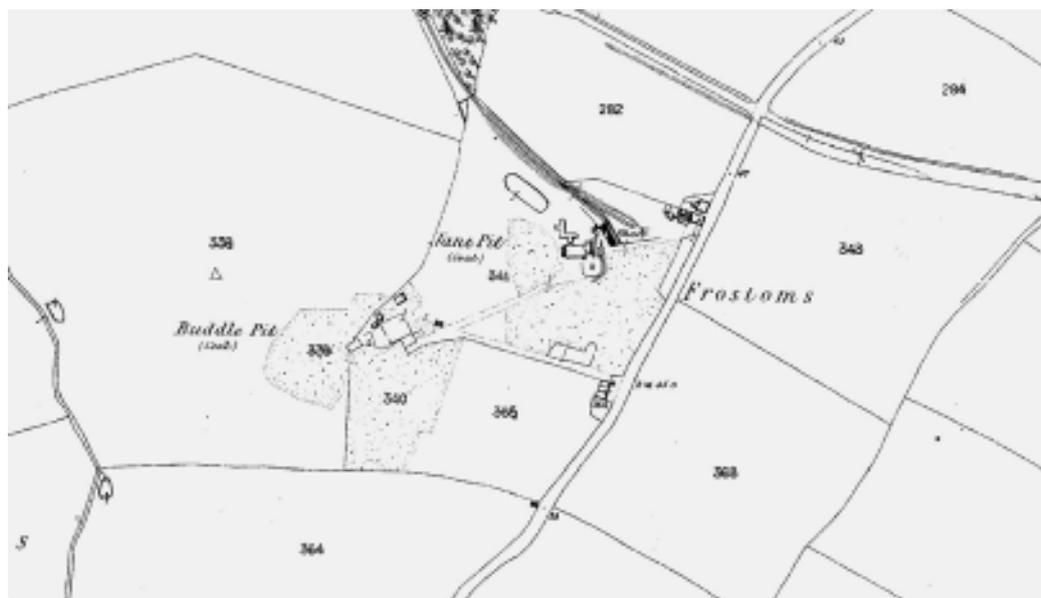
- 3.5.10 **OS map, 1895, 1:2,500 (Plate 12):** this more detailed map published in 1895 showed a plan of the structures at Jane Pit as they probably were during its main usage prior to its closure in 1875. North-west of the pit shaft and pit buildings at Jane Pit was an elongated oval, reservoir. The circular shaft was west of a large rectangular building at the southern end of the tramway leading west and then north to the Harbour. West of the shaft were two large structures: to the north was the L-shaped building with two small extensions on its southern and western sides. To the south was the larger rectangular building with a small square extension offset at its east end, within which was a circular foundation (probably the base of the chimney) and a porch at its western end; this was the location of the Engine House, either for a winding engine (Historic England 1017559) or for a pumping engine (Davies-Shiel and Marshall 1969, 117, 268; Neaverson and Palmer 2002). This large rectangular building had two direct links to a square feature with rounded corners (very nearly a circular feature) with a central shaft or apex. This was likely to have been the horse gin circle used to operate the winding mechanism for the shaft and was either powered by horses or with the steam powered engine thought to be housed in the large rectangular building to the north (Historic England 1017559).

Plate 12: Extract from OS map, 1895, 1:2,500

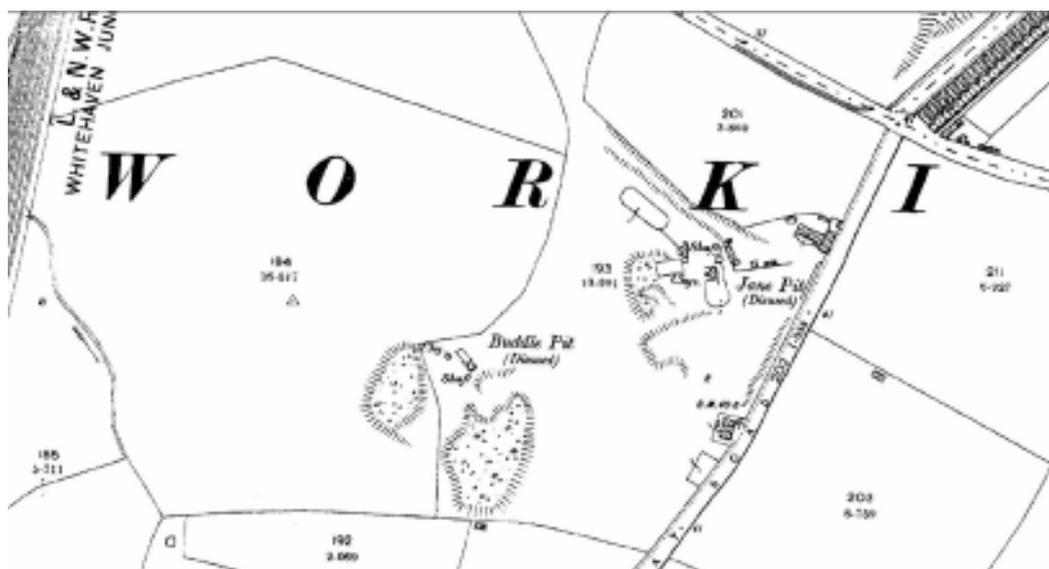
- 3.5.13 **OS map, 1900, 1:10,560 (not illustrated) and 1:2,500 (Plate 13):** on the 1900 OS edition, Buddle Pit and Jane Pit were both marked as disused and a further pit to the north of Annie Pit Lane, called Annie Pit, was also marked as disused (Annie Pit had not been marked on the OS 1st edition maps). Buddle Pit was the label for two large slag heaps and a third, much smaller, circular feature which, on the 1:2,500 map, was associated with a small rectangular building labelled 'shaft' with a chimney to the west. The tracks to the north/south road, now Mossbay Road, were no longer noted.

Plate 13: Extract from OS map, 1900, 1:2,500

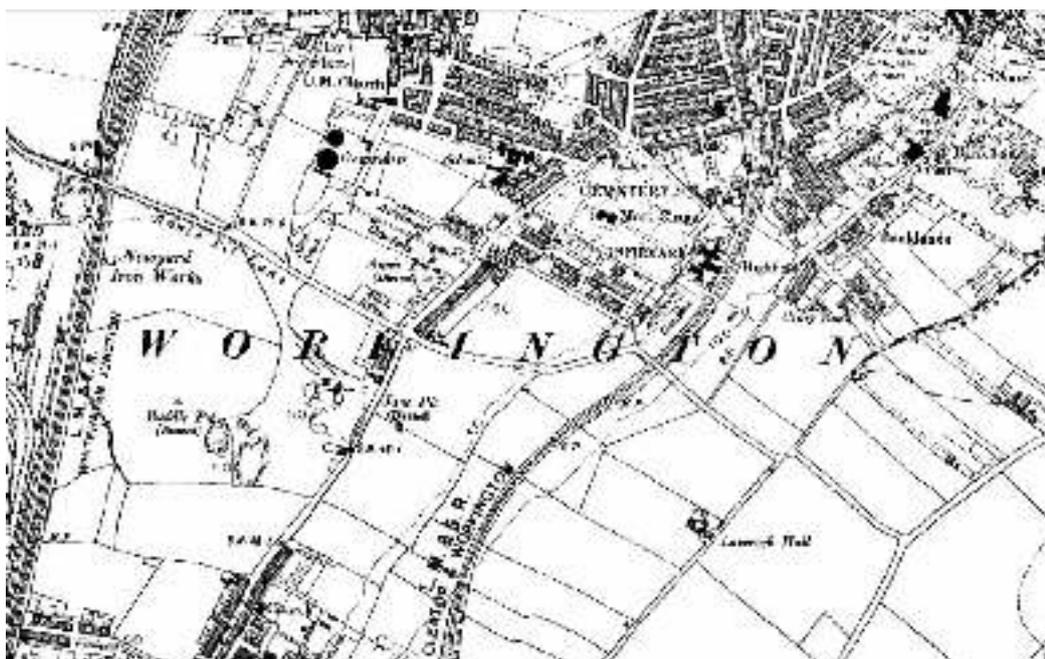
- 3.5.17 **OS map, 1925, 1:2,500 (not illustrated) and OS map, 1926-7, 1:10,560 (Plate 14):** on the 1925 maps there were no changes to the mapping of the structures and features at Jane Pit and Buddle Pit; however, the L-shaped wall was by now depicted as being alongside six unroofed square structures and one roofed structure. Holyoak Farm remained and to the north, there had been a new development of terraced row of eleven cottages each with a probable yard and privy. Here there was also was a larger enclosed piece of land to the west, probably allotment gardens as labelled on the 1959 mapping (Section 3.5.22). The three cottages at Frostoms were mapped.

Plate 14: Enlarged extract from OS map, 1926-7, 1:10,560

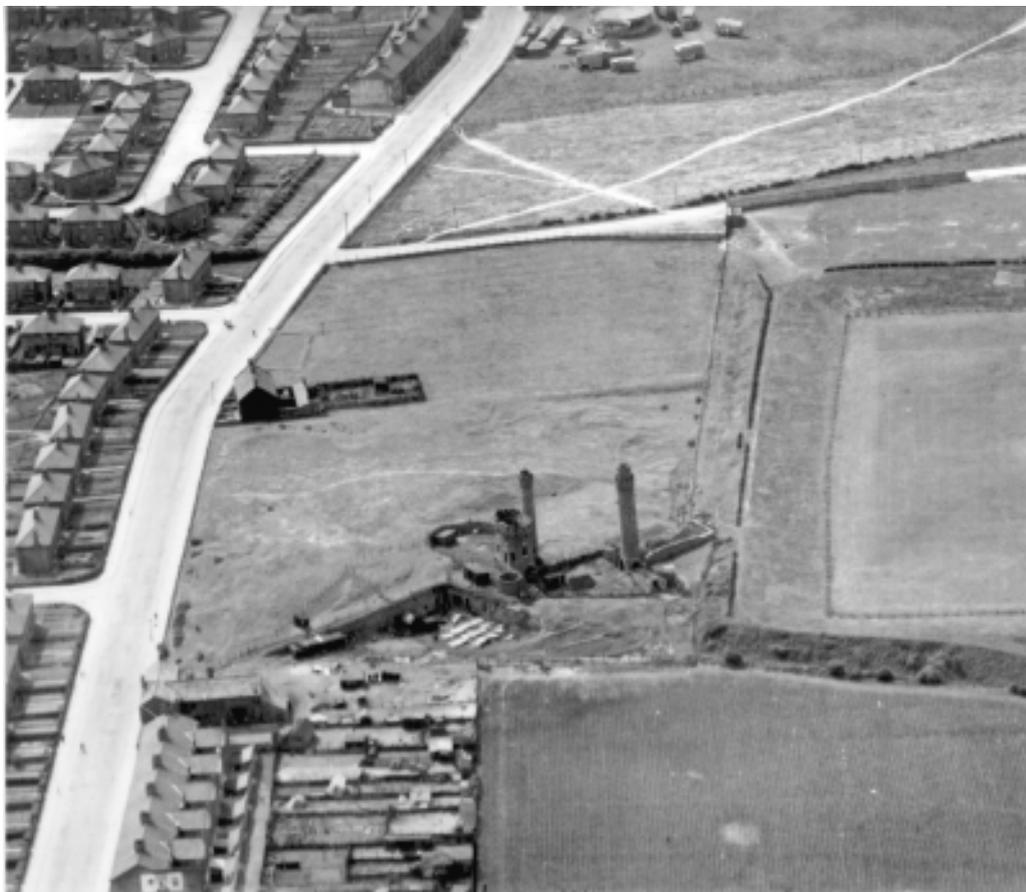
Plate 15: Extract from RAF photograph (RAF 540/A/413/PFFO/0265, 1949)

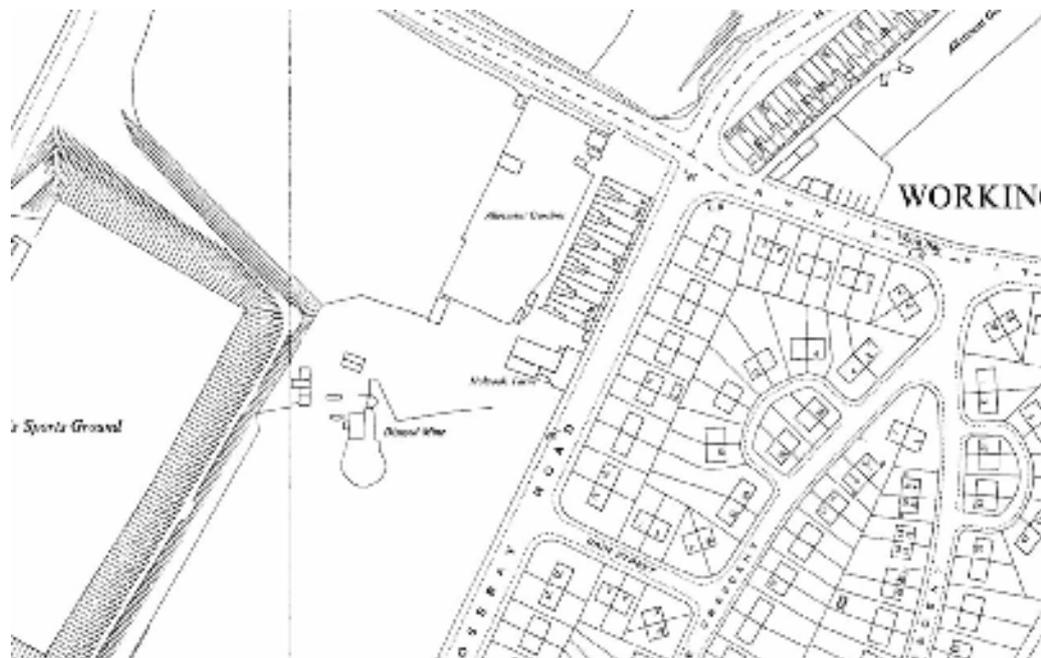
- 3.5.22 **OS map 1959, 1:1,250 (Plate 16):** this large-scale map showed that the earthworks of the nineteenth century horse gin-circle remained with the rectangular unroofed building to the north-west (the Engine House) and the round Shaft to the north. North-west of the old horse gin-circle was the row of four square unroofed structures, the southernmost of which was the detached Chimney (Historic England 1017559; Davies-Shiel and Marshall 1969, 117, 268) (Plate 17). North of the old horse gin-circle was a separate square building,

Plate 16: Extract from OS map 1959, 1:1,250

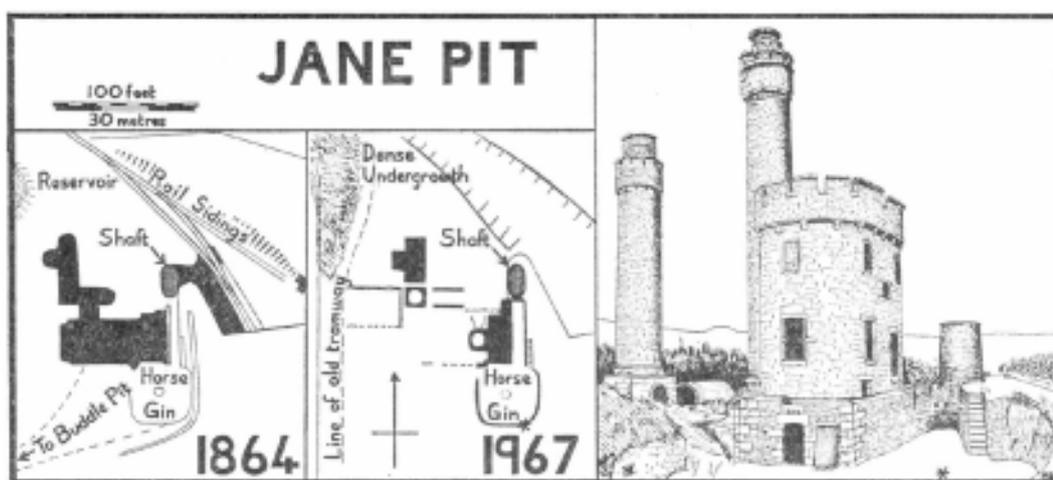
Plate 17: Plan of Jane Pit as seen in 1967 by Mike Davies-Shiel and JD Marshall

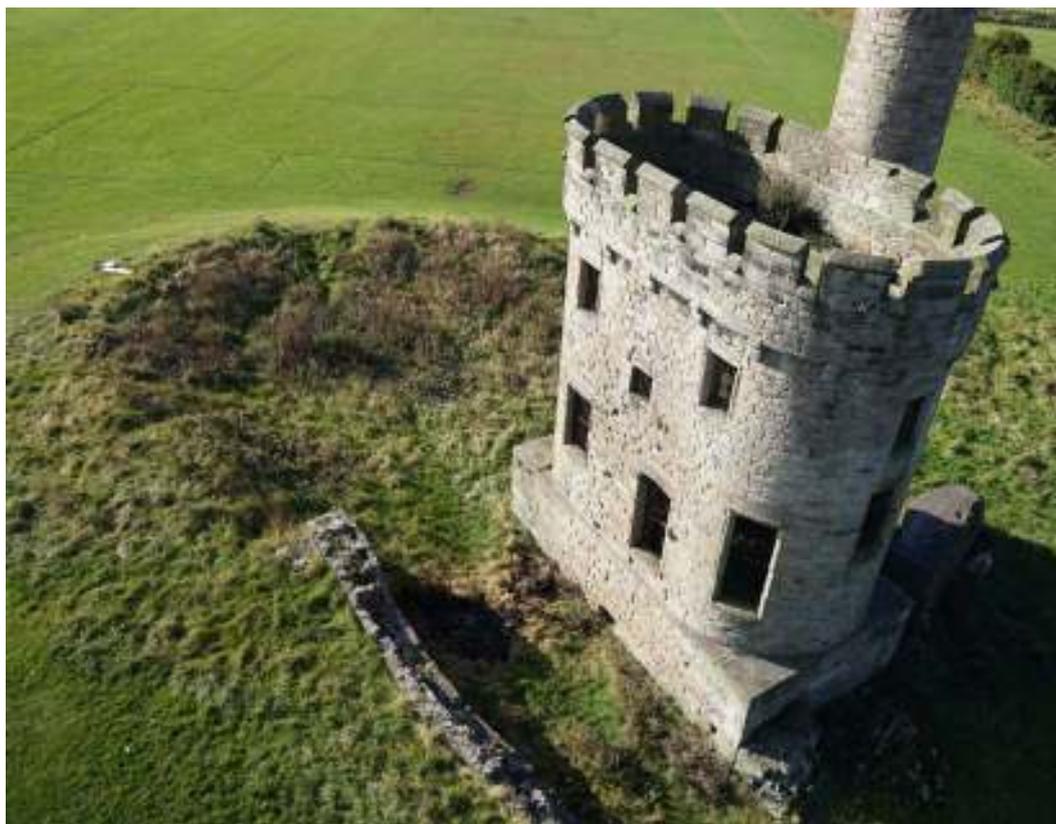
feature shown on historic mapping, which was the gin circle (or gin pit), where horses provided rotational power for winding, and which was linked, and probably in contemporary use with, the steam engine in the engine house (*Feature 1.2*). The 1949 aerial photograph shows this as being a sunken, sub-circular pit edged by a 2m high retaining wall, into the surrounding spoil heap. Now that the spoil heap has been removed, it is evident that the outer, embanked edge of the present gin pit, is a product of the recent landscaping and was not an original feature. The eastern side of the gin pit is continued by the north/south orientated line of a stone-constructed, retaining wall which is 1.7m high in places, and which leads between the gin circle and the former mine shaft. The walling was probably a continuation of the original retaining wall for the gin pit that was shown on the 1949 photograph, and the walling of the gin pit probably survives as a buried feature. A building / structure is shown within the gin pit on the 1949 air photograph, but there is no longer any earthwork feature corresponding to this and it was probably a wooden temporary structure. A similar structure was shown set above the north/south retaining wall and this also is no longer extant as an earthwork feature. Immediately to the west of the gin pit is an area of rough ground, truncated by the landscaping for the football field, with no discernible features and this area was shown as an area of featureless spoil heap on the 1949 aerial photograph.

Plate 18: Aerial view showing the gin pit earthworks (*Feature 1.1*) located beyond the engine house

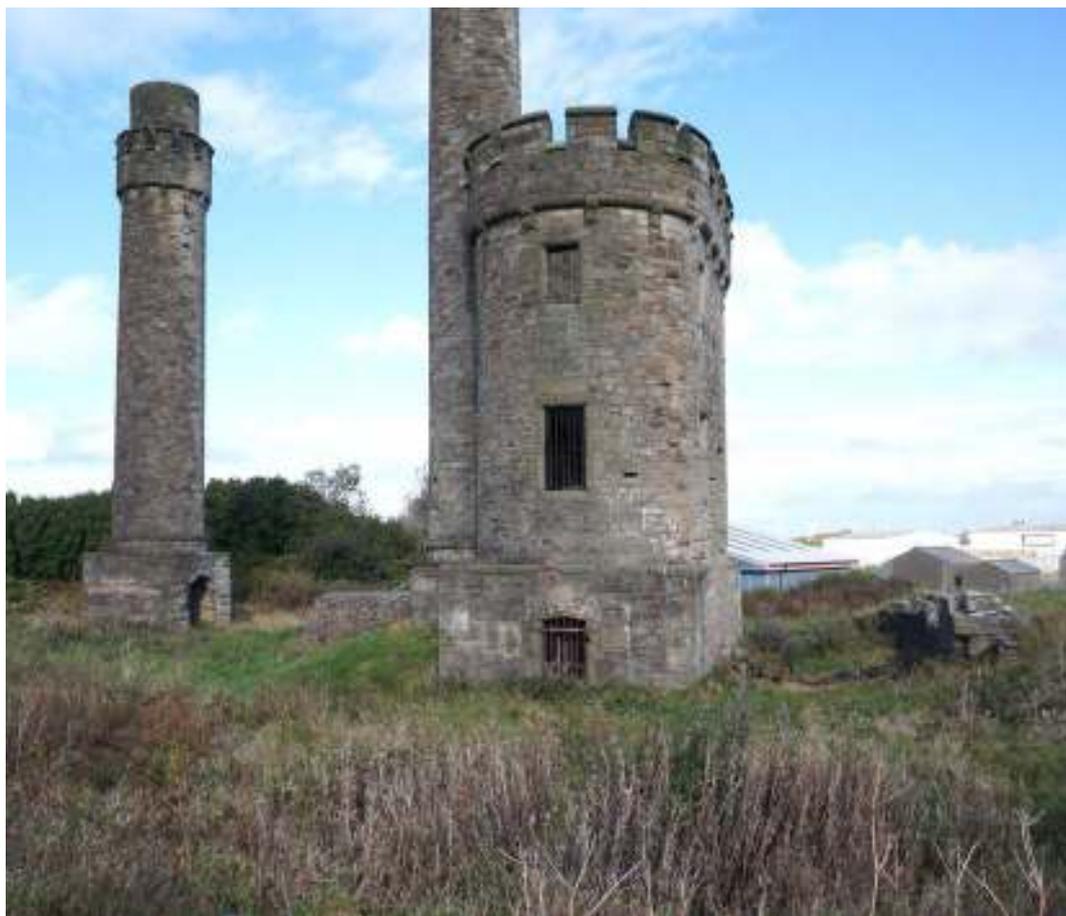
- 4.2.3 **Engine House (*Feature 1.2*):** the engine house is an elegant three-storey, two-bay oval tower built on a rectangular plinth, and finished with a crenelated parapet, which is externally supported on dressed corbels. Internally, there are floor joist sockets, corresponding to the two floors, only at the oval ends, but not in the

Plate 19: The southern end of the engine house (*Feature 1.2*) facing towards the gin pit.

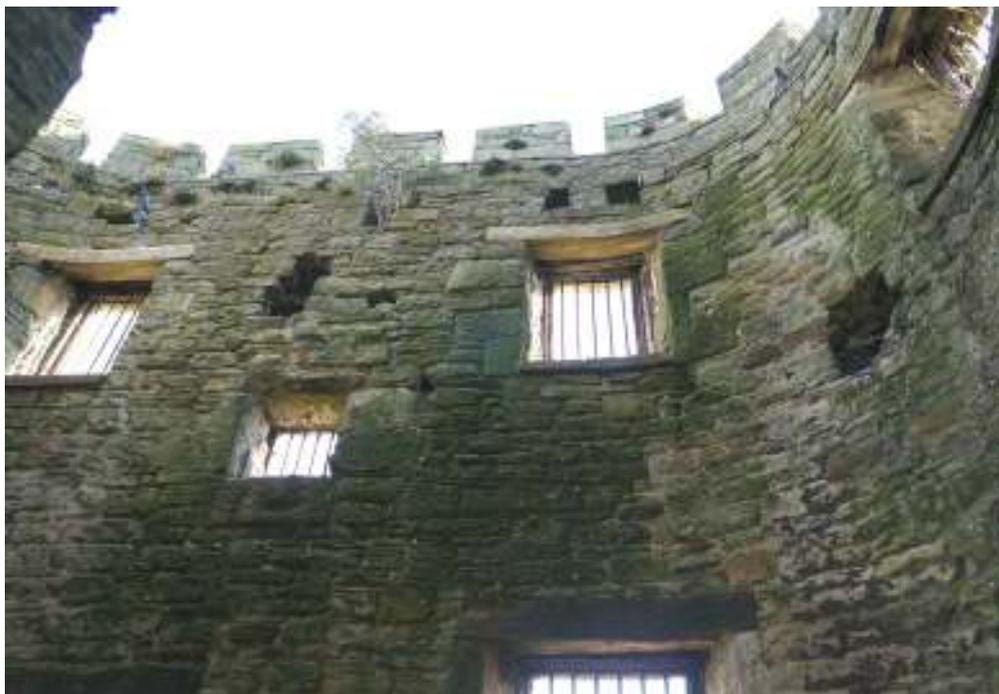
4.2.4 *Condition:* while the windows have ashlar lintels externally, most of the windows have soft wood lintels internally (Plate 20). Most of these wooden lintels are

showing signs of age and exposure to the elements, with bowing, cracking and signs of rot. One of the timber lintels has been reinforced with an iron beam, but most have no additional support. Any proposed maintenance should allow for their replacement or for the provision of additional support for these lintels as they are a potential source of structural failure. While the external skin of the engine house is structurally sound there are sections of the internal skin that have collapsed, and most notably around the north-western window of the first floor (Plate 21). The collapsed sections are principally around two windows, probably as a result of the failure of these wooden lintels.

Plate 20: The interior of the engine house, looking east, showing the timber lintels over the upper windows

- 5.2.1 The engine house externally looks strong and robust, and in need of little maintenance, but the interior tells a different story. Most of the inner lintels of the 12 windows are made of softwood, which were never intended to be subject to the full force of the elements. These have actually survived remarkably well, but are now showing distressing signs of deterioration (rot, cracking and bowing). There have been a number of points of collapse of the inner skin of the engine house walls, and these would need to be repaired as a matter of urgency lest they become more extensive. It is possible that these areas of collapse are as a result of the failure of timber lintels, as each is centred on the upper part of a window. It is recommended that a structural engineer, with experience of historic fabric, undertake an investigation of the engine house fabric and advise on remediation measures necessary to stabilise and maintain the building in its present state.

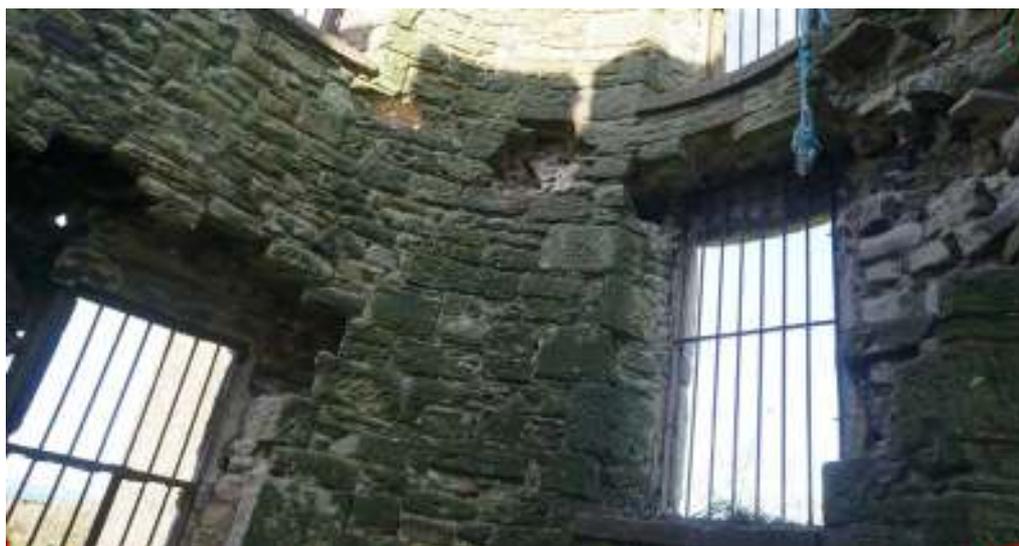
Plate 21: The interior of the engine house looking north-west, showing the sections of detached internal skin

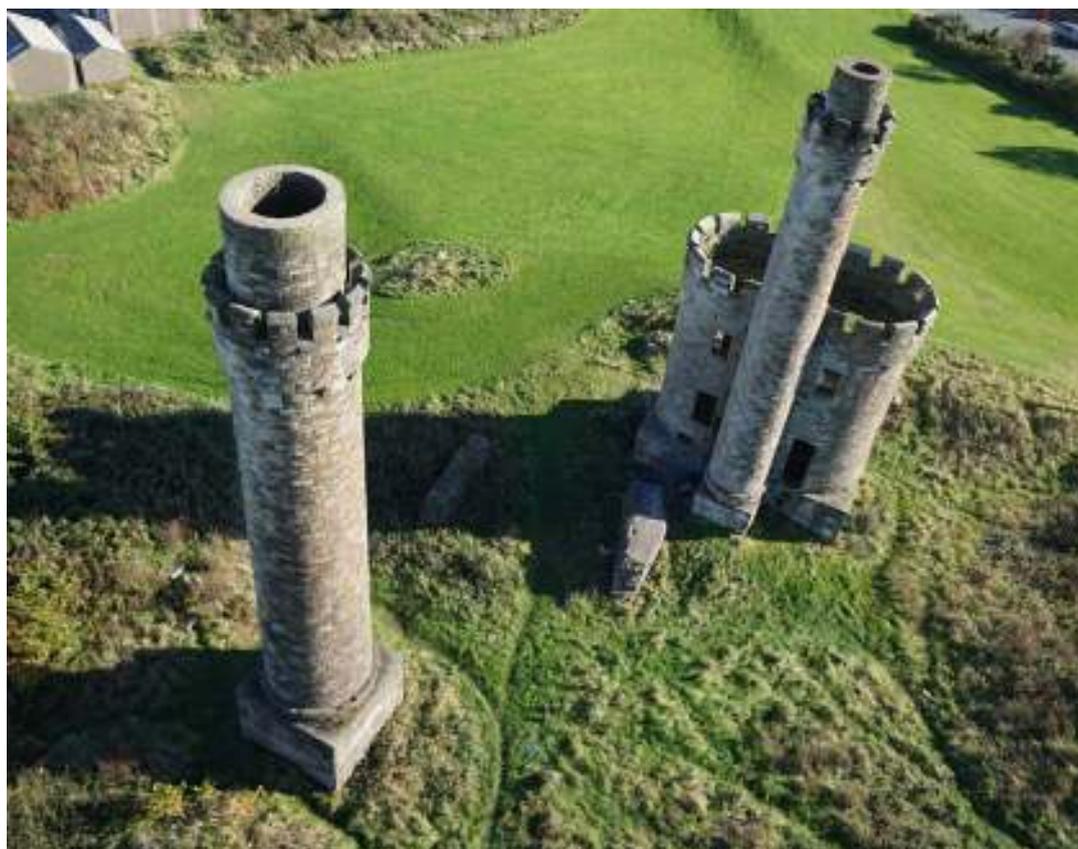
4.2.5 **Western Free Standing Chimney (Feature 1.3) (Plate 22):** what is now a detached chimney located to the west of the engine house, was originally set into the north-eastern corner of a low, rectangular building (Feature 1.4), orientated north-east/south-west, which was depicted on the historic OS maps and on the 1949 RAF aerial photograph. The chimney was constructed of hammer-dressed calciferous sandstone forming a round chimney on a square base. It had two arched stoke holes extending through the northern and eastern sides of the square base (the western and southern sides were obscured by the rectangular structure (Feature 1.4)). The northern stoke hole is edged by ashlar quoins, and was ornate and intended to be seen. By comparison the eastern arch is faced by more roughly-dressed stone and now incorporates brick voussoirs and quoining, although these were not necessarily original (Plate 23). It would appear that the eastern face, at ground level, was functional and was not intended to be seen. The design of the chimney closely matches that attached to the engine house (Plate 22), both having a crenelated outer parapet, below the neck of the chimney, supported by corbels. Similarly, both have a protruding ring band just above the square base which was purely ornamental. The only notable difference is that the western chimney had a substantially larger diameter, both internally and externally, although both had a broadly similar height. The detached chimney has an inscribed stone 'E.S.C Esquire 1844'.

Plate 22: The two similar chimneys albeit of different diameters, looking east

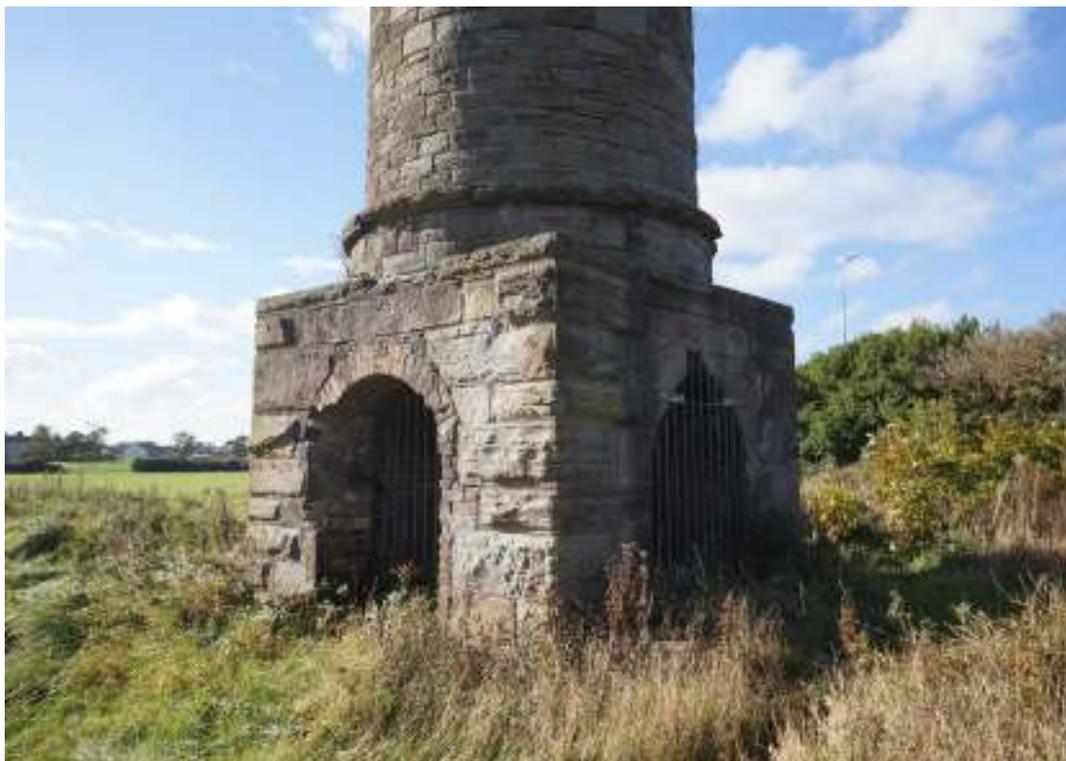
Plate 23: The base of the detached chimney showing the different design of the stoke holes

- 4.2.6 The 1949 RAF photograph shows a ramp extending north from the northern stoke hole, with an aperture at its northern end, and was perpendicular to the orientation of the low rectangular building (*Feature 1.4*). This ramp would probably have been part of the former engine house shown on the 1895 and 1900 OS mapping, but was only partially extant on the RAF photograph. The ramp is no longer extant and there is no indication of it as an earthwork; however, this particular area is now heavily overgrown and it is possible there are subtle remains that are presently obscured.

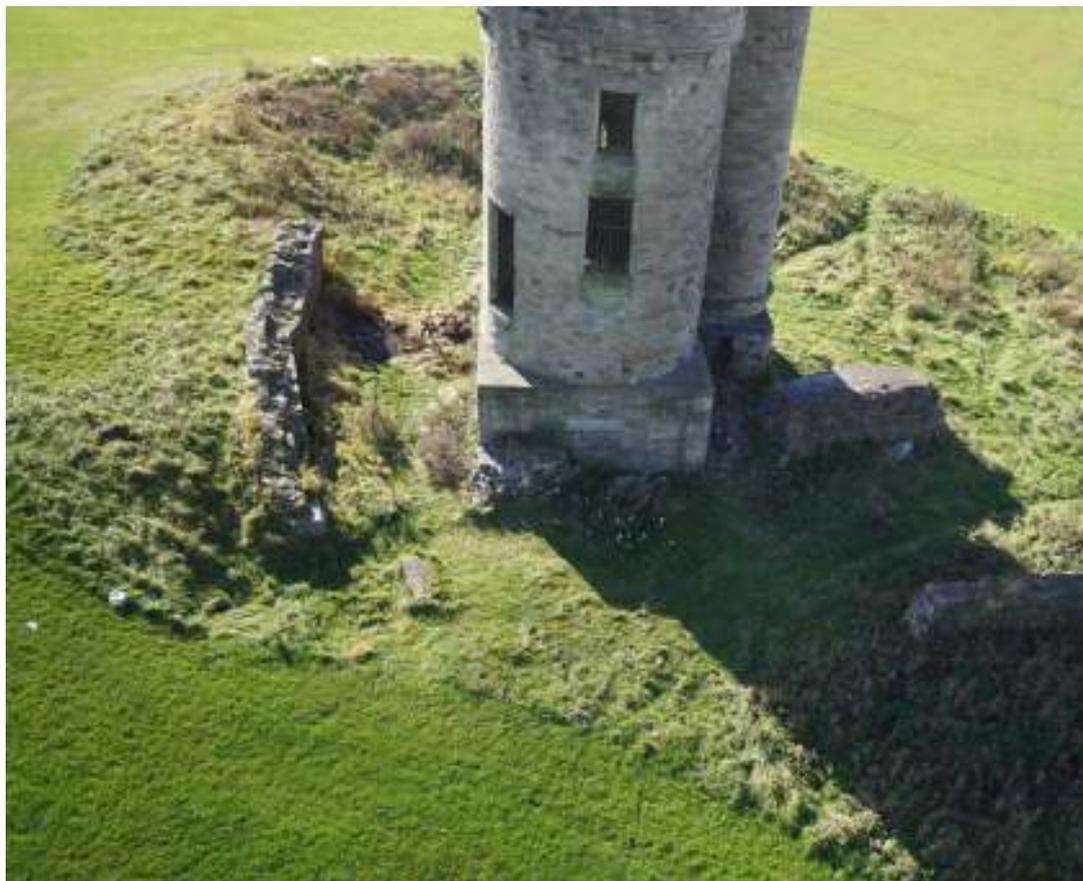
wall, which would appear to correspond in location to the former shaft. Although the vegetation cover in this location is not particularly dense, cutting it back may allow further clarification of the form of the shaft.

Plate 24: Aerial image showing the earthwork hollow at the northern end of the retaining wall, which corresponds in location with the shaft

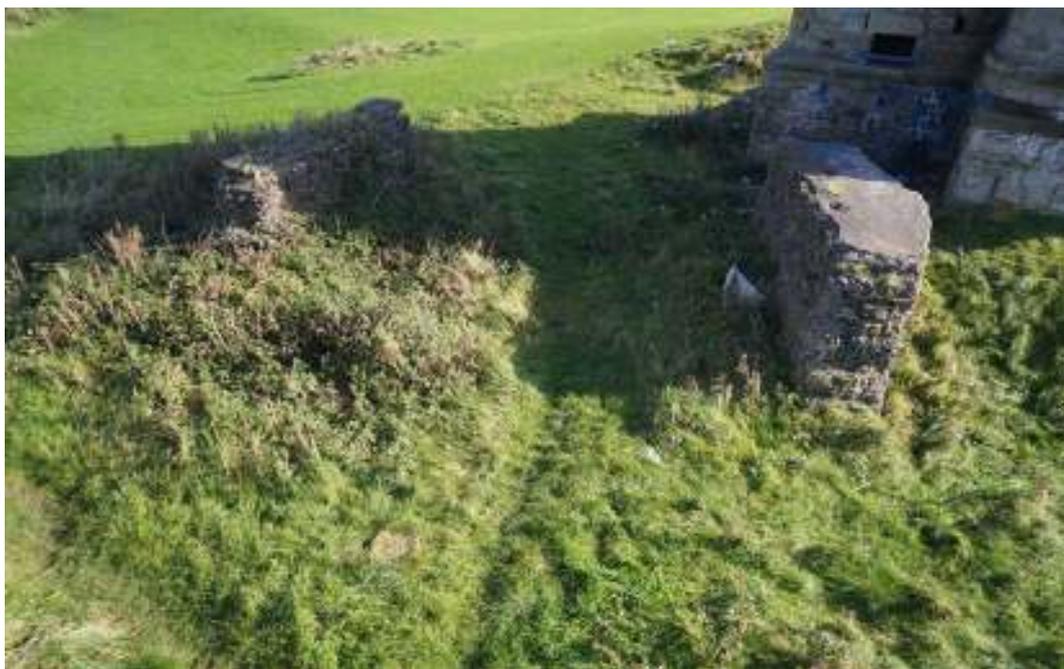
- 4.2.9 **Connecting Wall (Feature 1.6) (Plate 25):** the RAF 1949 aerial photograph shows a section of retaining wall that forms the northern edge of a large spoil heap to the south of the mining complex. The wall formed the southern boundary of an open yard between the engine house and the detached chimney, and extended between the north-western corner of the engine house and the south-east corner of the rectangular building (Feature 1.4). The line of this retaining wall is now followed by a short concrete linear short structure (Feature 1.6), which is up to 2m wide. While this is extremely broad for a simple earth-retaining wall, its southern edge corresponds with the line of the retaining wall shown on the 1949 aerial photograph and it was either a part of this wall or it was constructed against the retaining wall.

- 4.2.10 A further fragment of brick and concrete (Feature 1.8) (Plate 25) is now extant to the north of the section of retaining wall. It was shown as such on the RAF aerial photography, which also showed it to be an isolated structural feature, located in the yard formed by the retaining wall. Its function is unknown and cannot be reliably ascertained from its current form or its depiction on the aerial photograph.

Plate 25: the two seemingly independent fragments of brick and concrete adjacent to the engine house (*Feature 1.8* is to the left of the photograph, and *Feature 1.6* is to the right).
