JANE PIT, WORKINGTON, CUMBRIA

Desk-Based Assessment and Landscape Survey Report

Oxford Archaeology North

October 2016

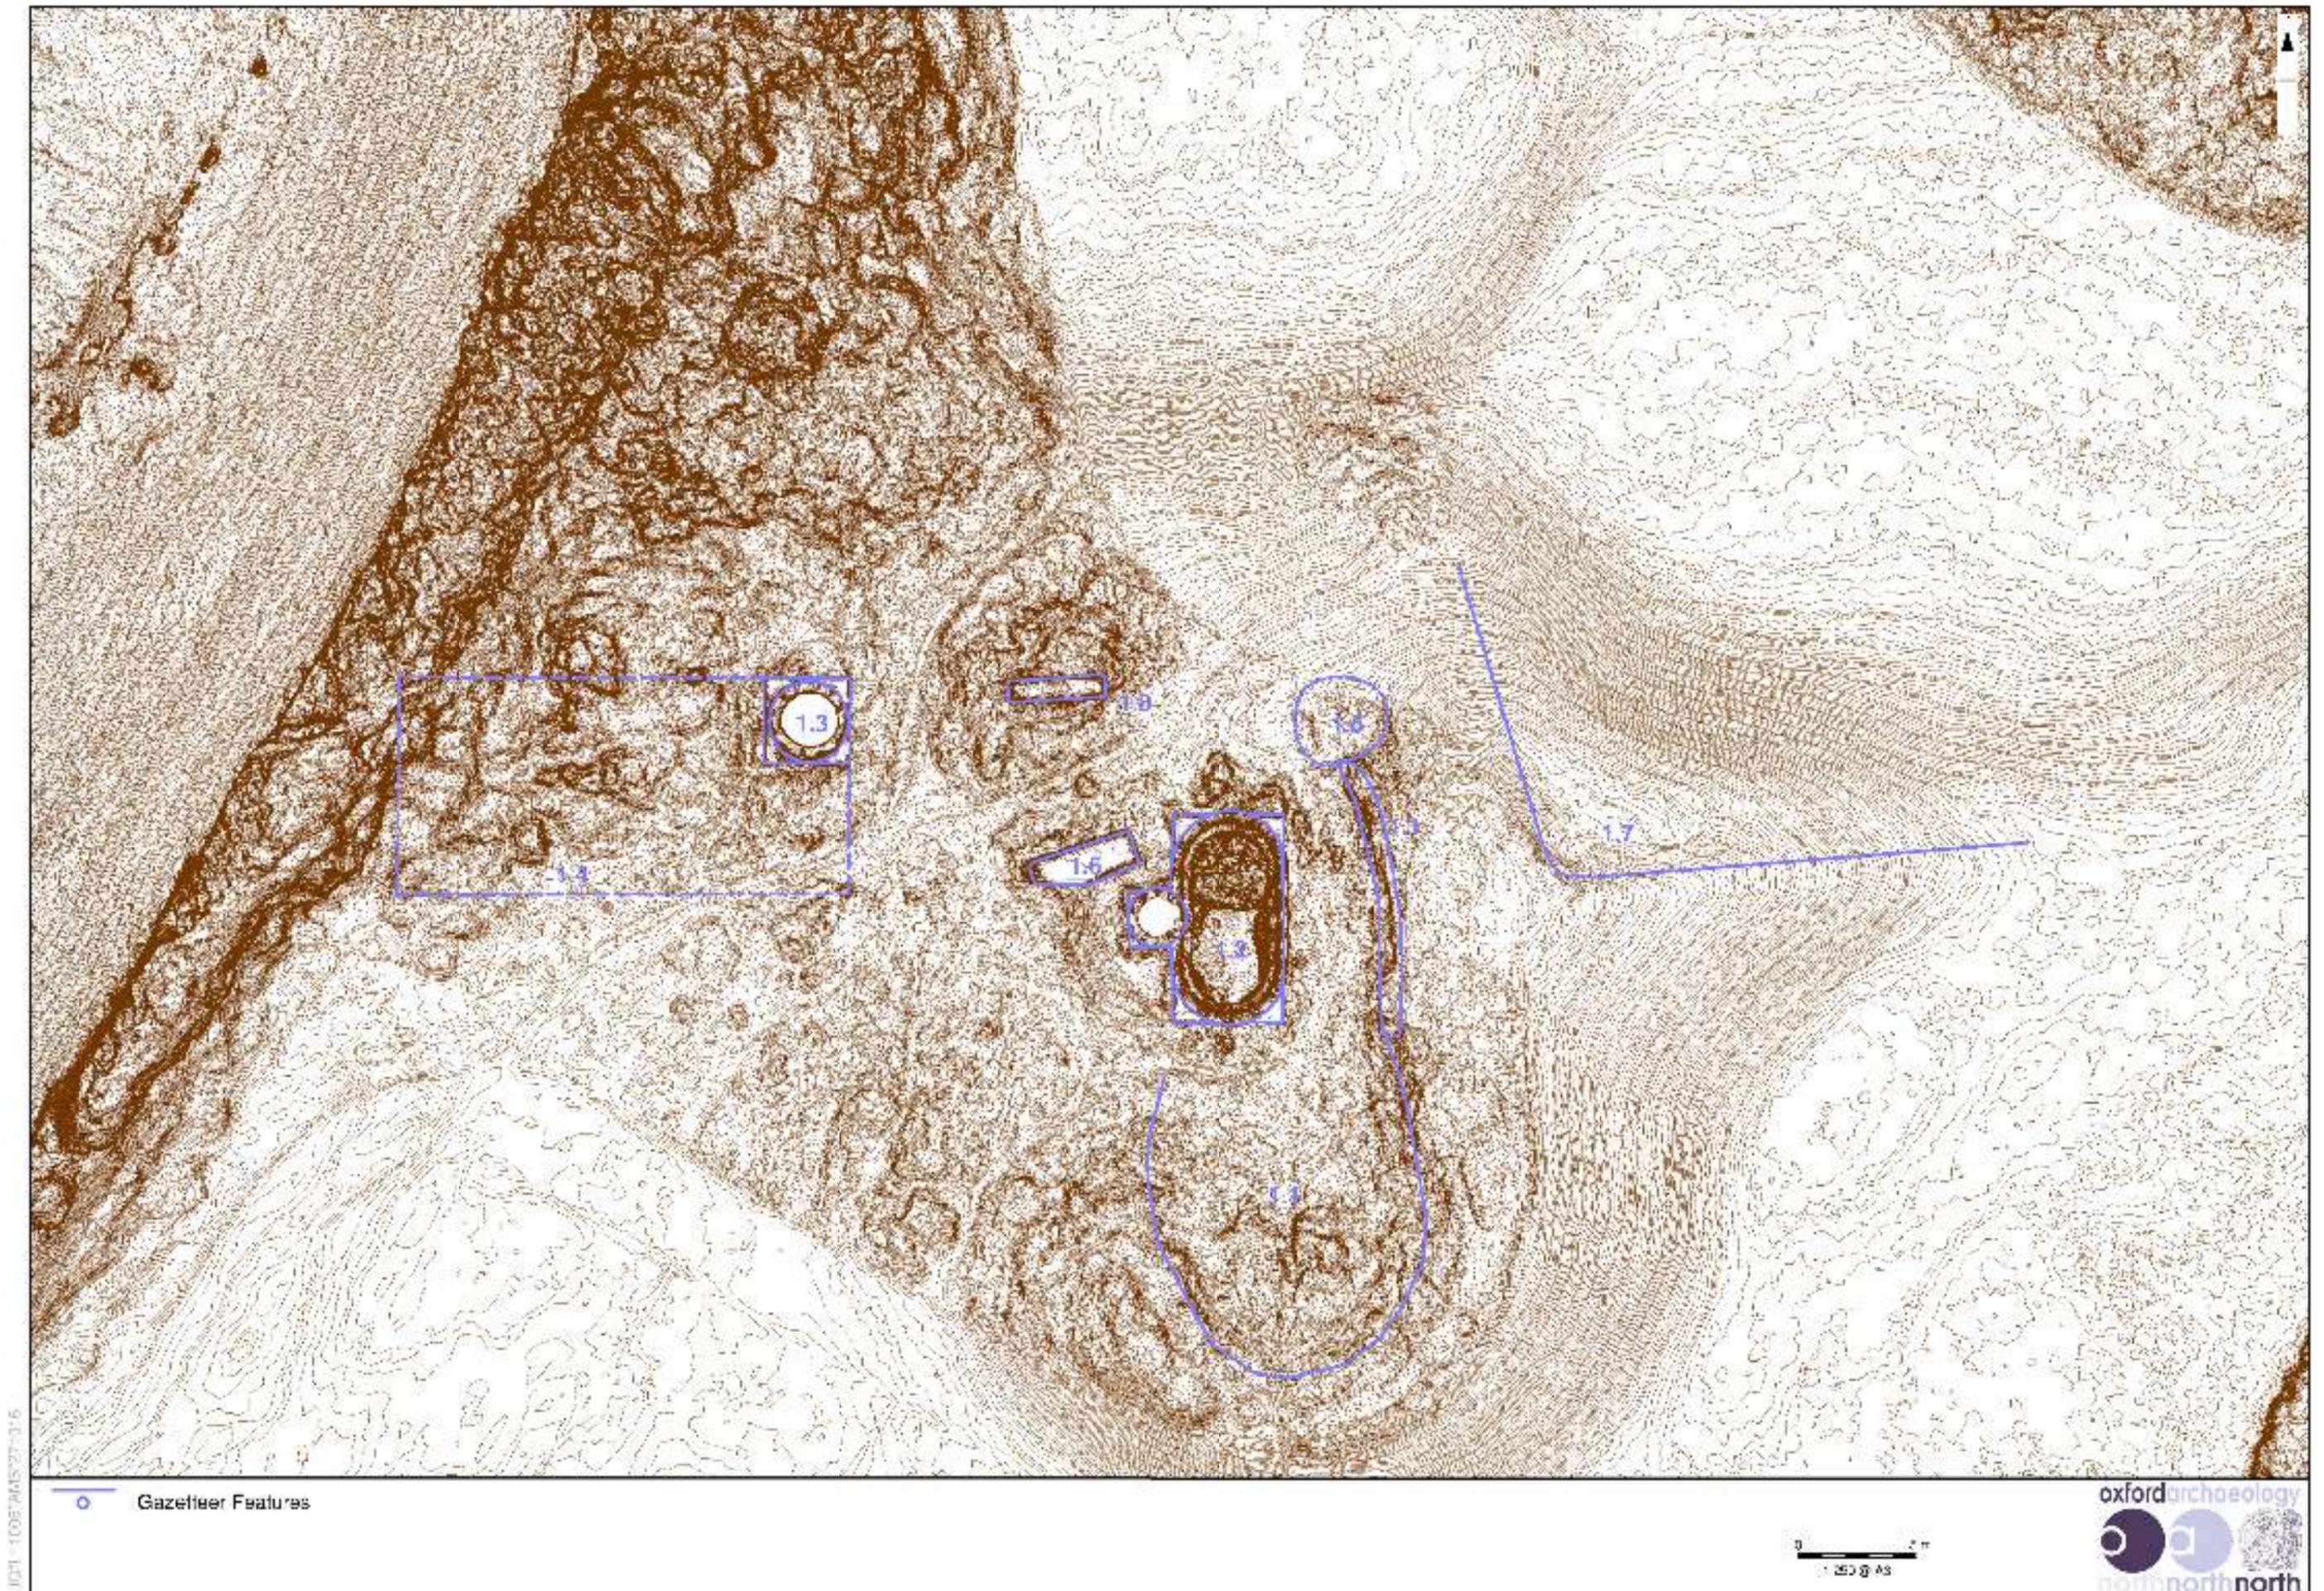
Figure 2: Gazetteer of Sites

- 4.2.1 The range of extant features identified during the survey are described below and are defined further within the site gazetteer (*Appendix 1*) and are shown in Figure 2. The overall Jane Pit site is defined as Site *1* and its individual features are numbered *1.1 to 1.8*.
- 4.2.2 **Gin Pit (Feature 1.1) (Plate 18):** to the south of the Engine House (*Feature 1.2*) is an elliptical enclosure, which is open to the north facing towards the engine house. It is partly obscured by vegetation, but survives as an earthwork, with a sharply defined interior edge, and a flat base. This matches closely with the

3.1.1 **Introduction:** the following section presents a summary of the historical and archaeological background of the general area in order to place the study area into a wider context. This is then followed by a more detailed historical examination of the sites themselves. Sites identified by the study are presented in a site gazetteer (*Appendix 1*) and also on Figure 2.

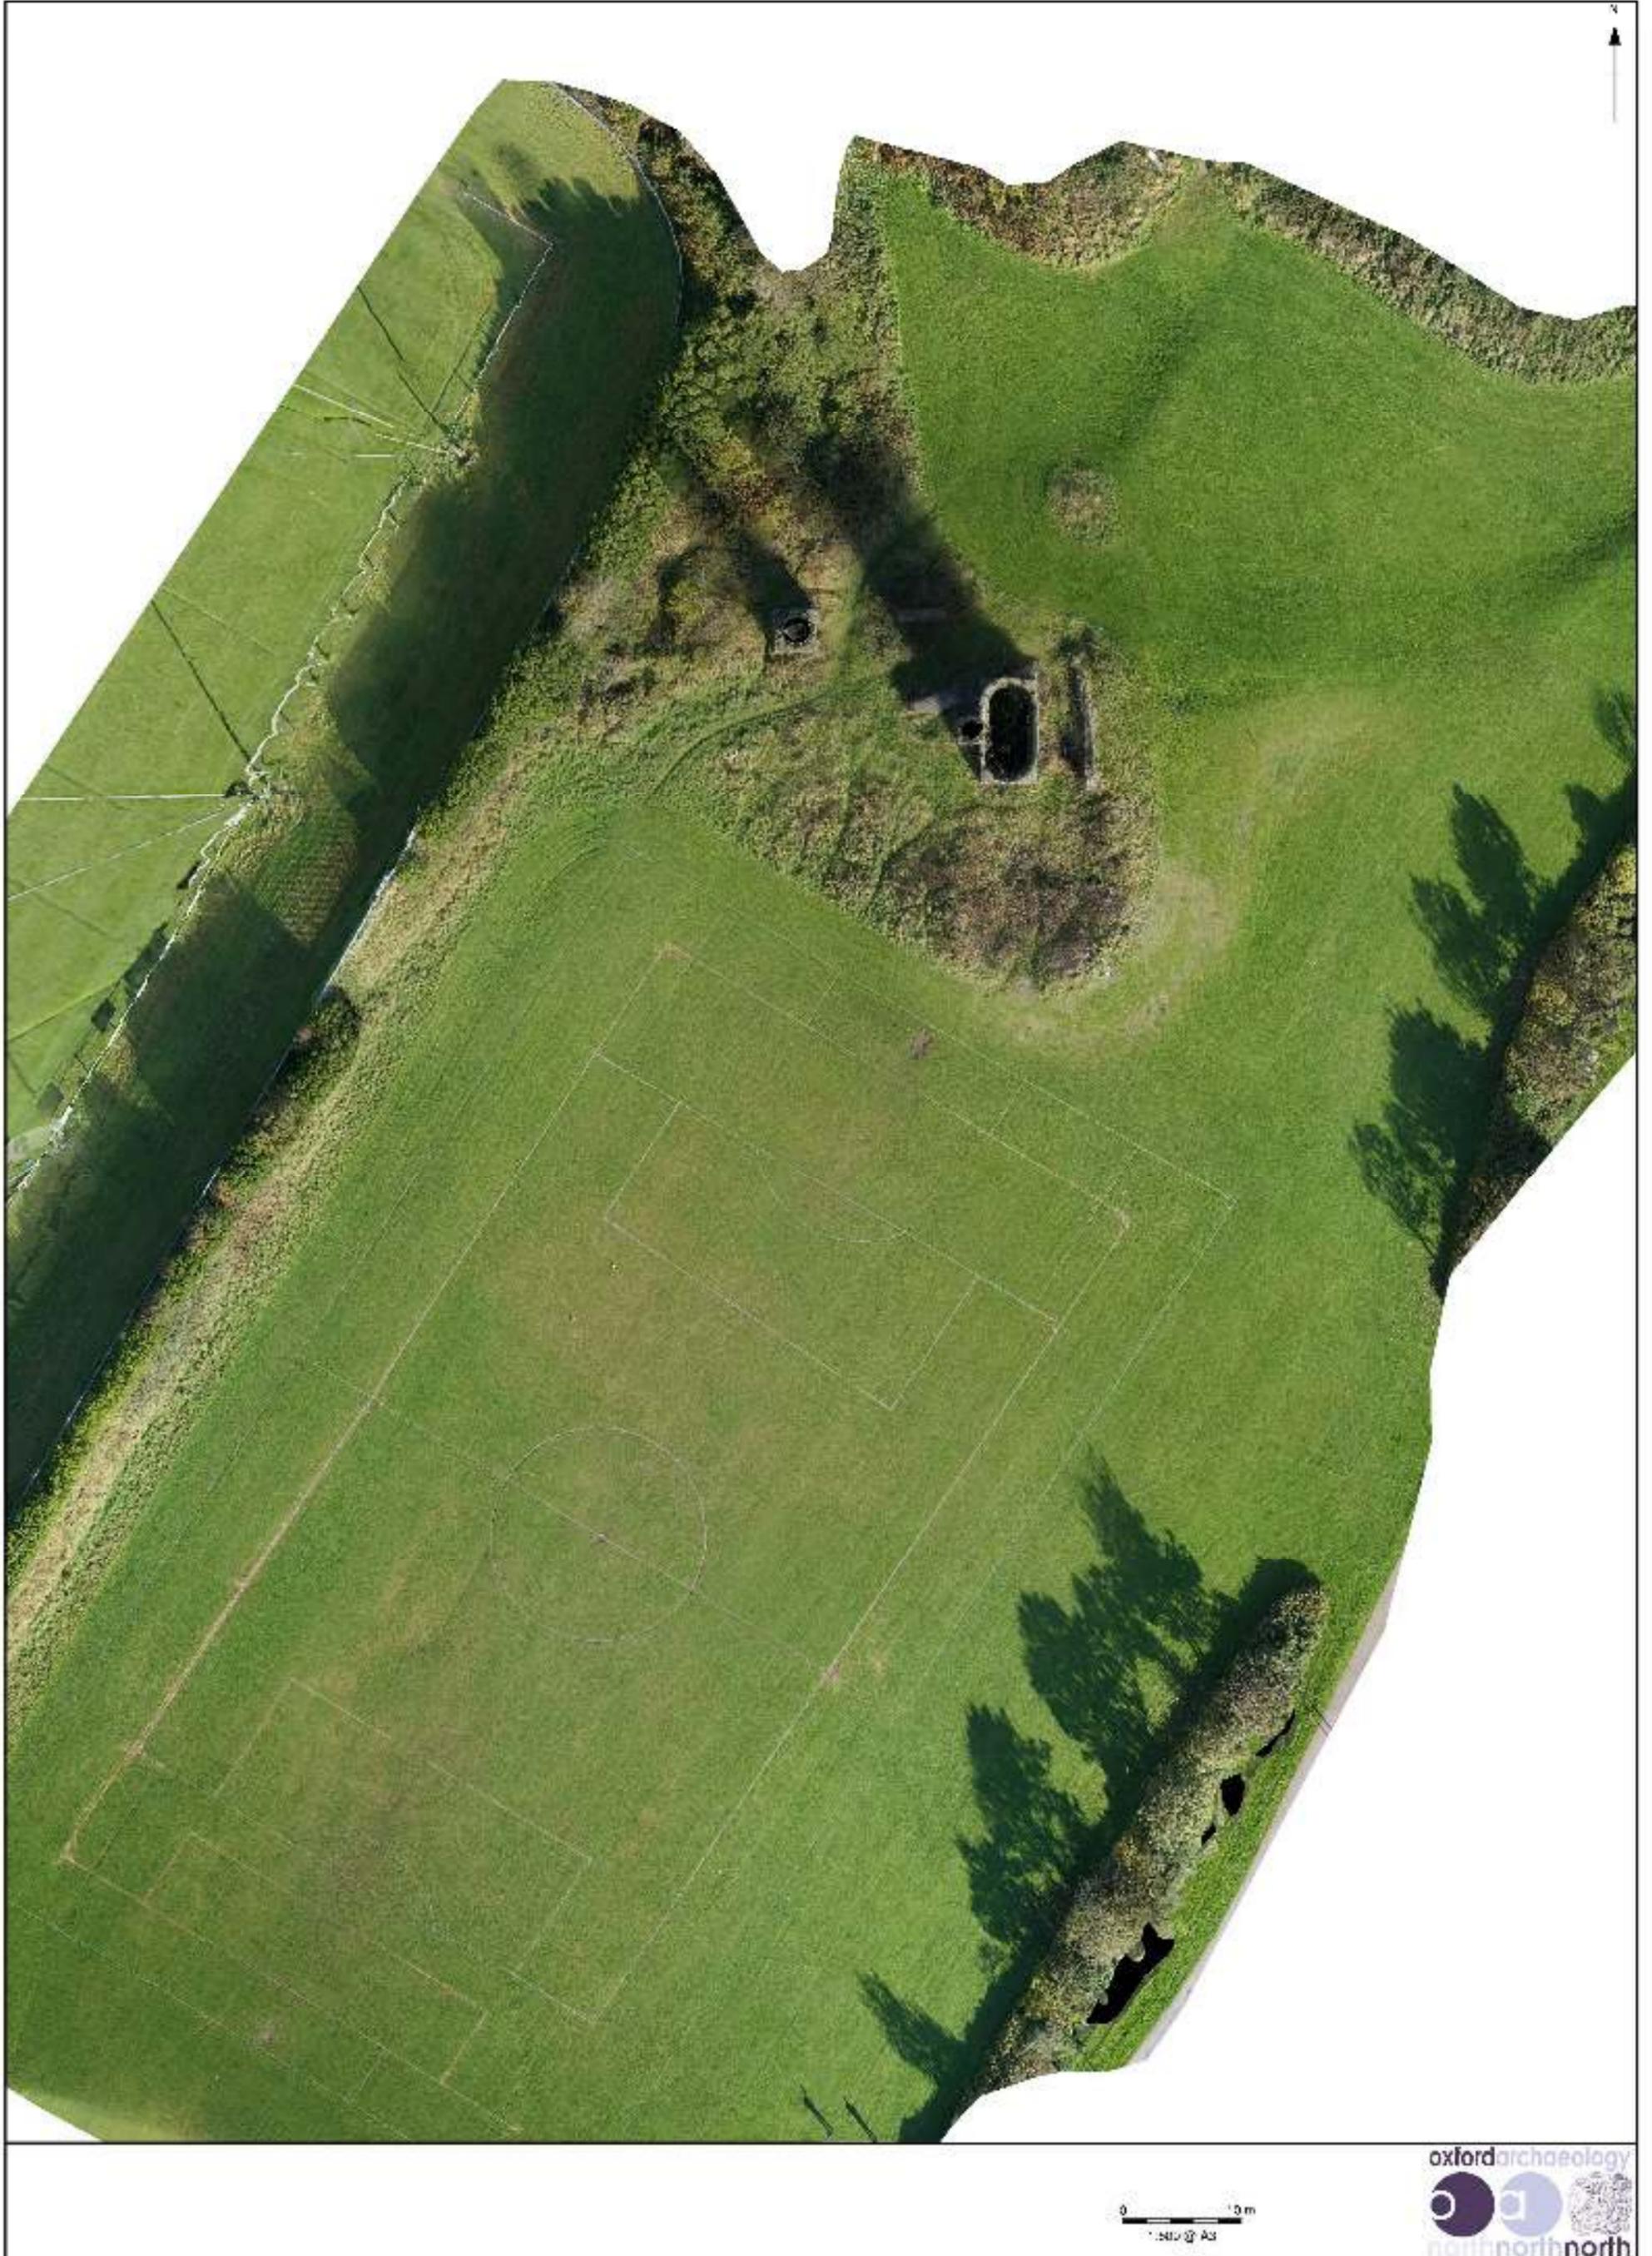
Figure 6: Orthophoto of the wider Jane Pit Landscape

- 2.2.6 Photogrammetric processing was undertaken using Agisoft software which provided detailed modelling using an overlap of up to 250 photographs, and created a very detailed DTM (Digital Terrain Model) across the site. The photographs were then digitally draped over the model to create an accurate three-dimensional orthophoto of the ground surface (Figs 6 and 7). The output of the model comprised hill-shade views of the overall landscape (Fig 5), detailed contour views (Figs 3-4) and a wider orthophoto of the area (Fig 6). Detailed modelled coverage of the buildings was also obtained but not reproduced in this instance.
